## 7.0 Non-Aboriginal context

### 7.1 Historical overview

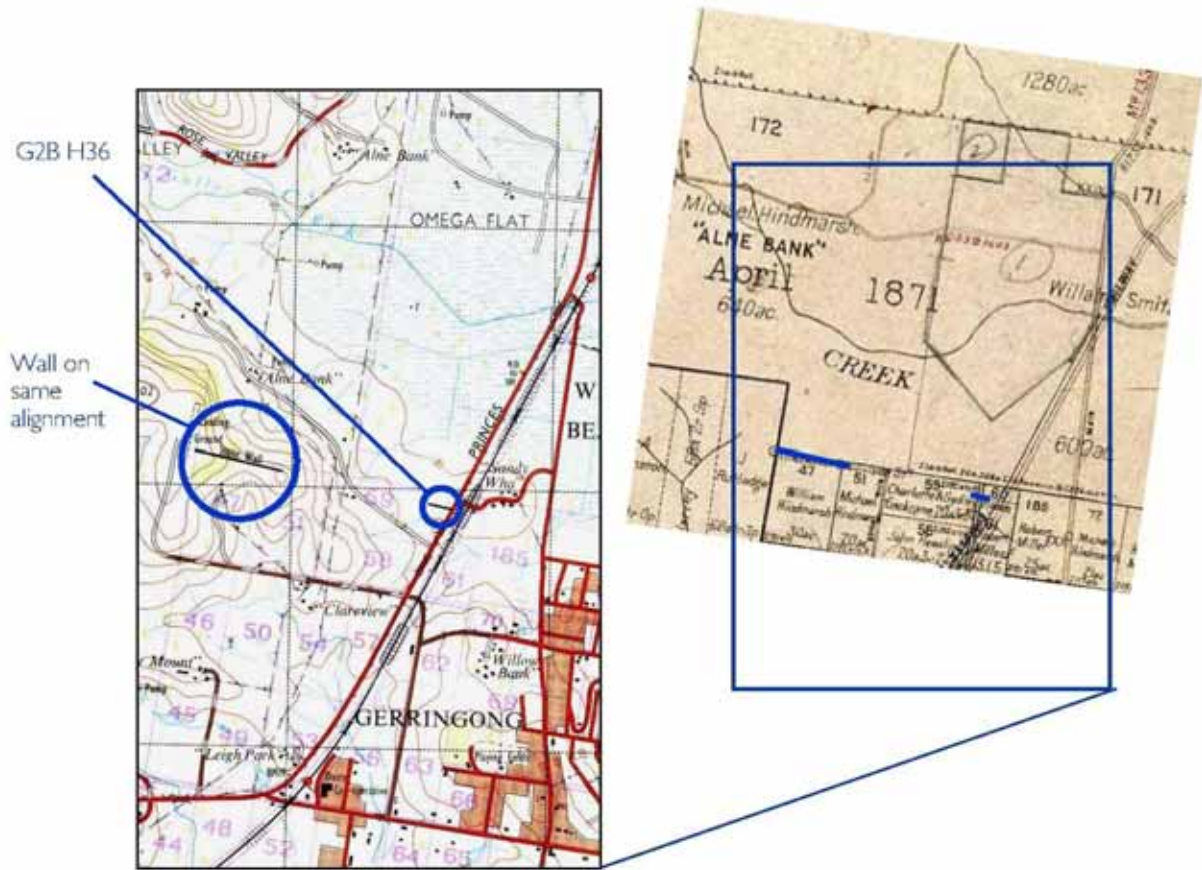
Figure 8.73: G2B H36 – Location of early stone wall (yellow) relative to modern residential buildings and more recent northern boundary stone wall (red)

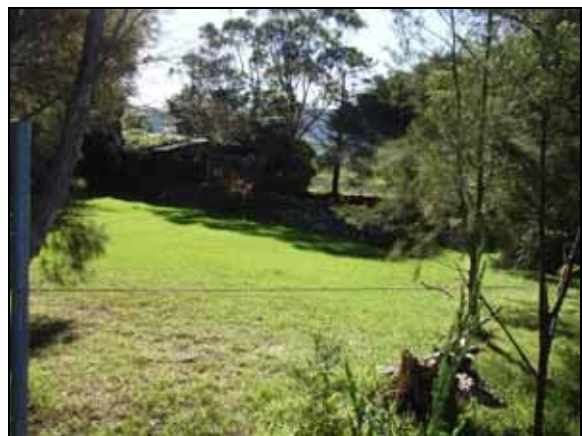
Figure 8.74: G2B H36 – General view of early stone wall situated south of the modern block boundary, looking north-west

The early wall remnant is approximately 50 m long and extends (with one gap) from the southern side of a modern metal clad building towards the eastern boundary of the lot, where it ends at the boundary of the current crown land Princes Highway easement. The fence is around one metre to 1.1 m high and has been constructed with sloping sides to form a base approximately one metre wide (Figure 8.74 to Figure 8.76). Construction of this wall probably followed the 'double-dyke' method where two inward leaning walls are in-filled with smaller stones and a stone capping is placed on the walls apex. The orientation of the wall (looking west) is 267 degrees magnetic.

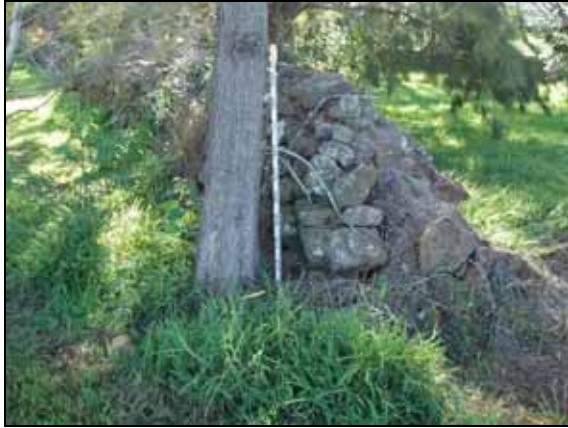
Figure 8.75: G2B H36 – Detail of eastern end and south face of early stone wall (scale is extended 95cm)

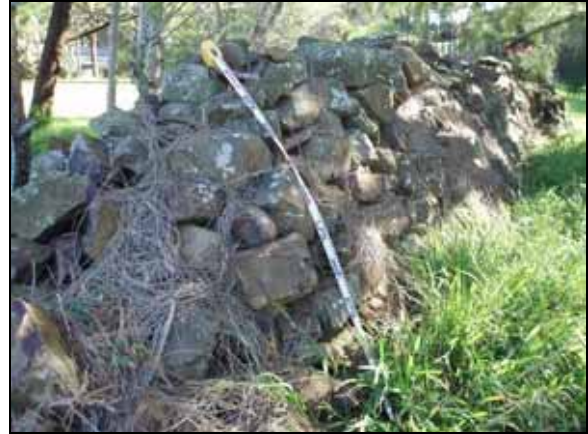
Figure 8.76: G2B H36 – Detail of eastern end and north face of early stone wall (scale is extended one metre)

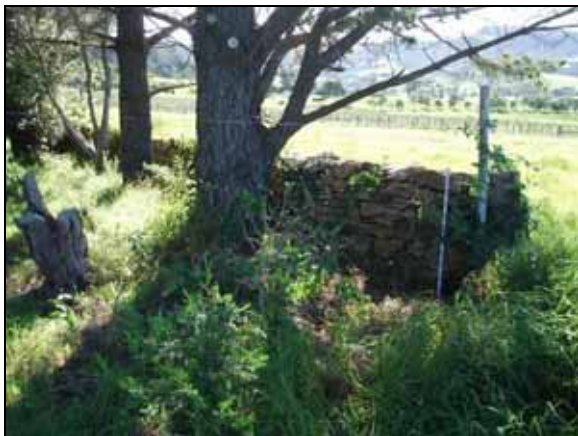
Figure 8.77: G2B H36 – General view of more recent stone wall along northern boundary of modern lot

- The lack of advanced patina on many of the rock used.
- The different construction, using narrower and near vertical walls.
- The close relationship of the walls with modern features such as the driveway and the amended northern boundary of the subdivision allotment (Figure 8.77 and Figure 8.78).

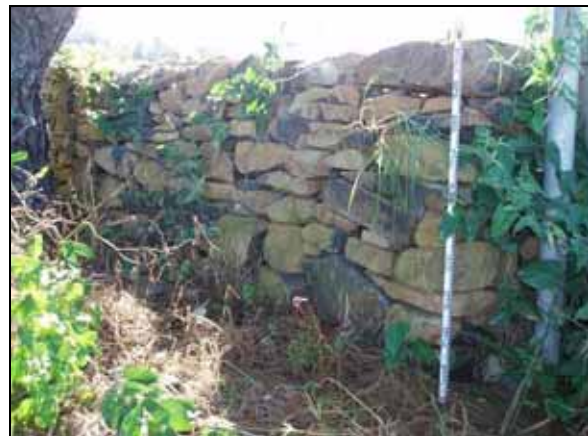
Figure 8.78: G2B H36 – Detail of south face of more recent stone wall (scale is extended one metre)

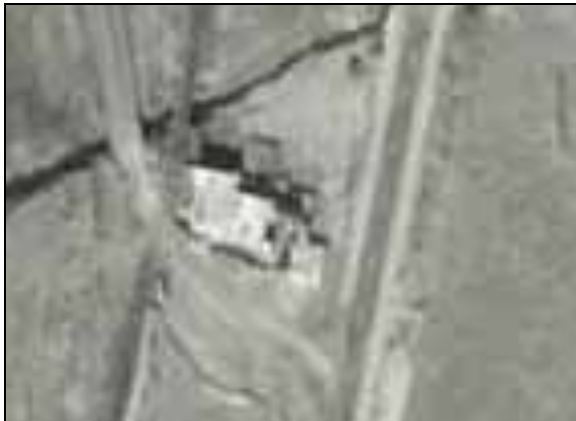
Figure 8.79: G2B H37 – Extract from a 1958 aerial photograph showing the location and arrangement of the former stationmaster's residence [south is up]

The building was still extant in 1958, but no longer present in 1970 (based on aerial photography and topographic mapping). The current metal sheds on the site post date 1990.

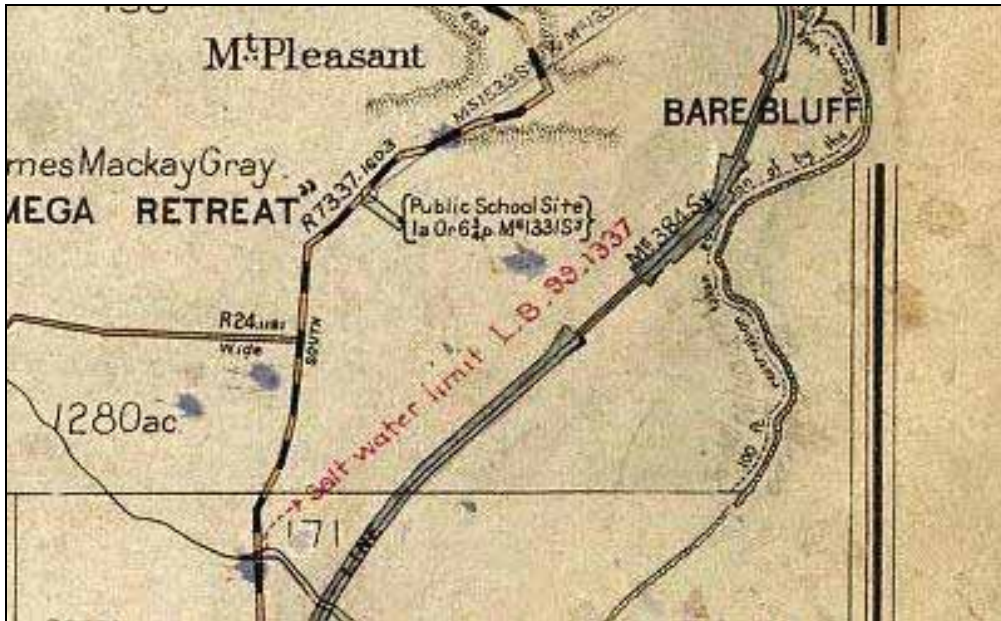
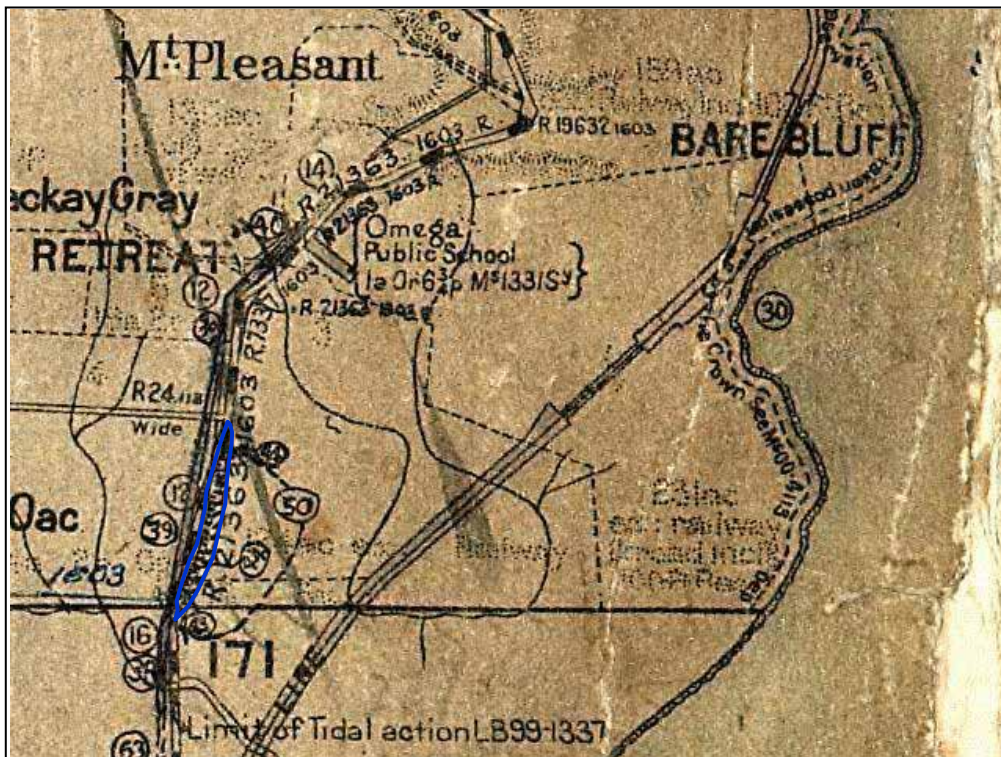
Figure 8.92: Extracts from the parish maps of Broughton, showing straightening of the highway easement, just north of *Renfrew Park*. The new road alignment was resumed in November 1939 (map notes 43 and 44), and the former road easement (outlined in blue), was closed and vested in the adjacent land owner in October 1943 (note 50)

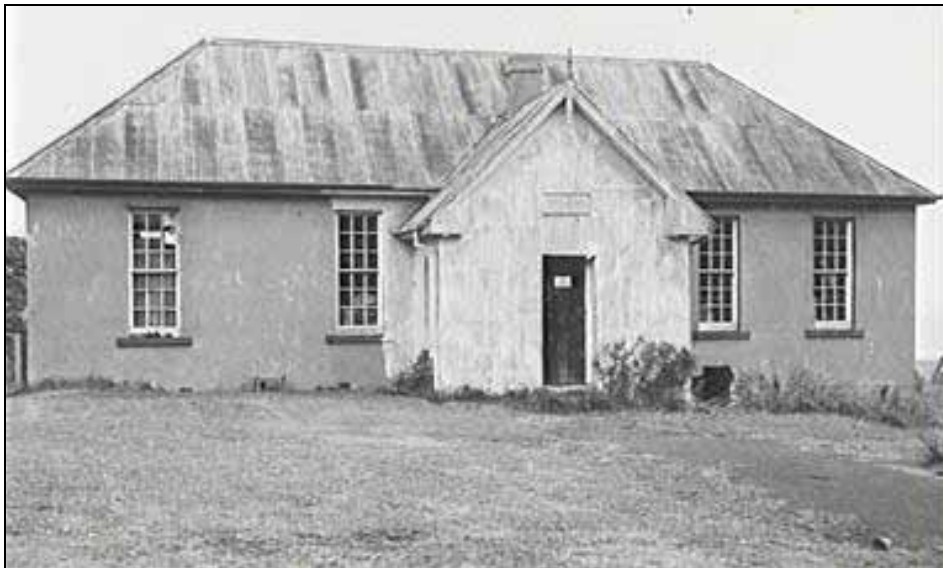
Figure 8.95: The Omega Public School in 1958 (Wollongong City Library W.A. Bayley Collection)

The original building appears to have been aligned north-west – south-east, parallel to the highway, and positioned some 75 m from the highway easement, allowing for a large front play area. The building is of masonry construction with a hipped roof and a central gabled porch (Figure 8.95).

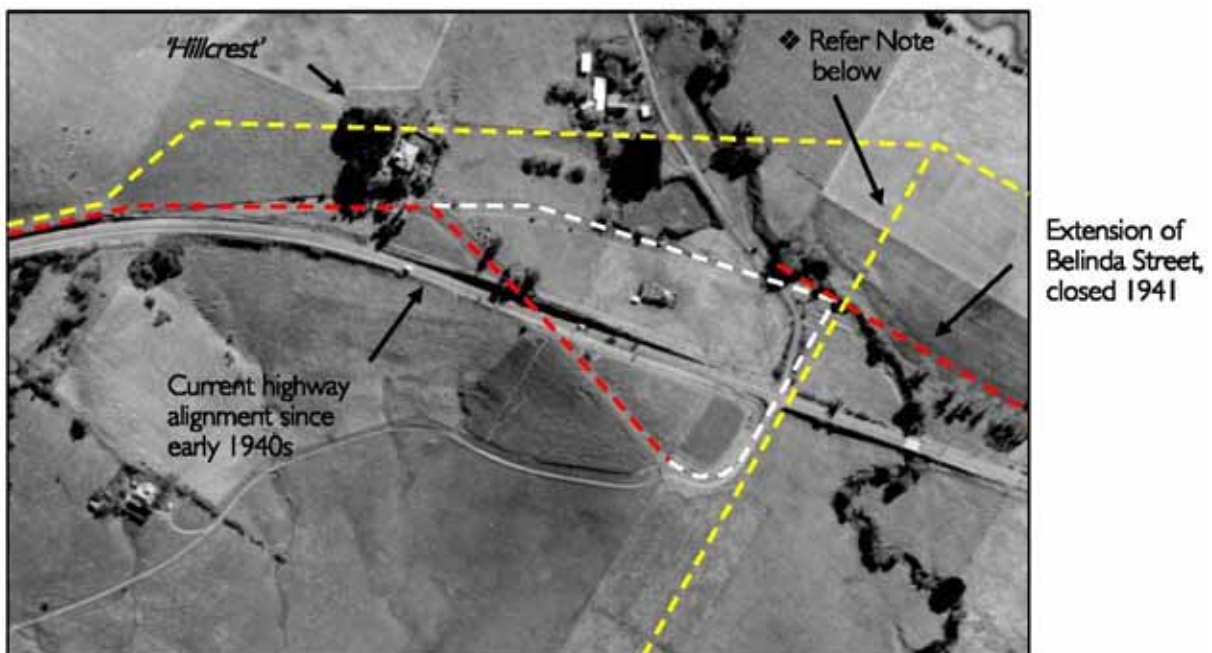
Figure 8.96: Extract from 1958 aerial photo showing a number of remnant highway alignments adjoining the Willowvale Road intersection, just west of the Crooked River

This recording comprises two remnant sections of the Princes Highway which were bypassed by construction of the current straightened alignment in the early 1940s (see Figure 8.96, Figure 8.97 and Figure 8.98). The two remnants divided by the current highway extend across a combined distance of 250 m. The northern end of the alignment was situated at a bend adjacent to the 'Hillcrest' homestead, site of a former Berry Estate tenant farm of 69 acres held by a G. Lee (see Figure 7.12). Buildings belonging to the Crooked River Winery are now situated on this location.

The roadway is evident only as micro-surface relief across the current pasture and is the only remaining feature of a number of former sequential road alignments in this area. These were more evident in 1958 and are described and traced in a number of overlays in Figure 8.96.

Note: *Technically this alignment should match the property boundary evident 25 m to the left. The alignment shown is based on a tracing of the 1866 county map and the shift to the right may be a mapping error. Despite this, the shift does provide an explanation for alignment of the modern cross street which is unusually also shifted away from the cadastral boundary*

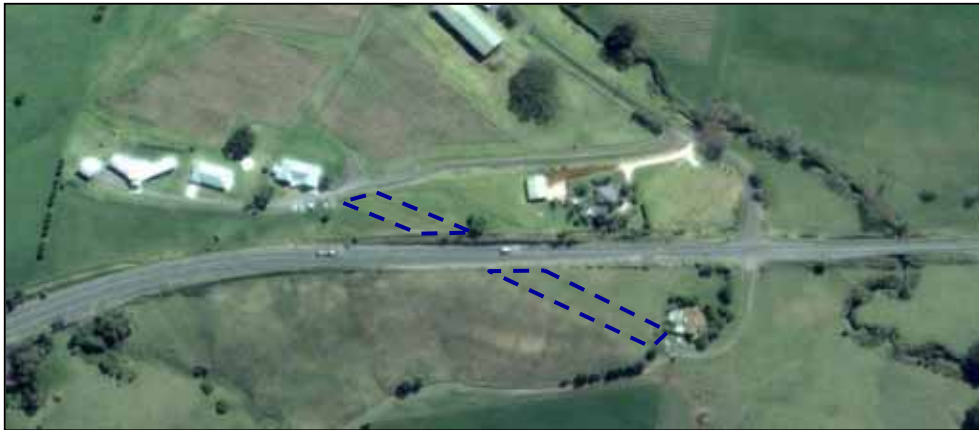
Figure 8.98: Extract from Parish map of Broughton 7<sup>th</sup> Edition (In use between 1938 and 59), showing straightening of highway to the east and west of the Crooked River crossing. The western extension of Belinda Street was closed in January 1941 (note 48), and the two cut off corners on the west side were closed in 1946 and 47 (notes 58 and 59)

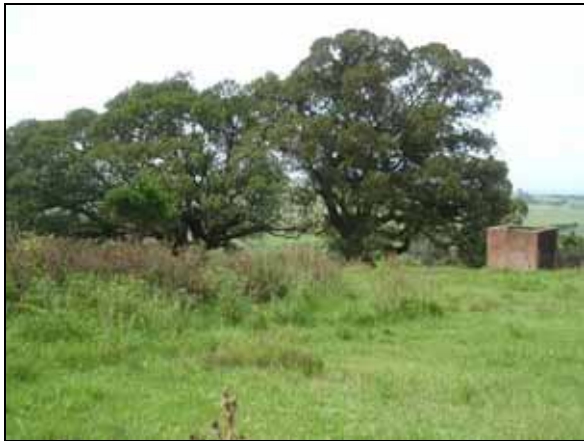
Figure 8.99: G2B H42 – general view looking south across low pile of debris thought to be the remains of the homestead hearth (left foreground)

- 1) A low pile of debris including bricks, rock ceramic pipe and a fragment of a cast iron stove, which are considered to be the approximate location and remains of the homestead hearth (pers. Comm. Geoff Bailey 2010) (see Figure 8.99 and Figure 8.100).

- 2) A square brick walled tank placed on a foundation of sandstone flagstones which may relate to an earlier and much larger structure (see Figure 8.99 and Figure 8.101).
